Santa Barbara Catch Basin Inlet Storm Drain Screens Project

**DATE:** December 2011

Storm Water Quality Improvement

**Submitted by the City of Santa Barbara**

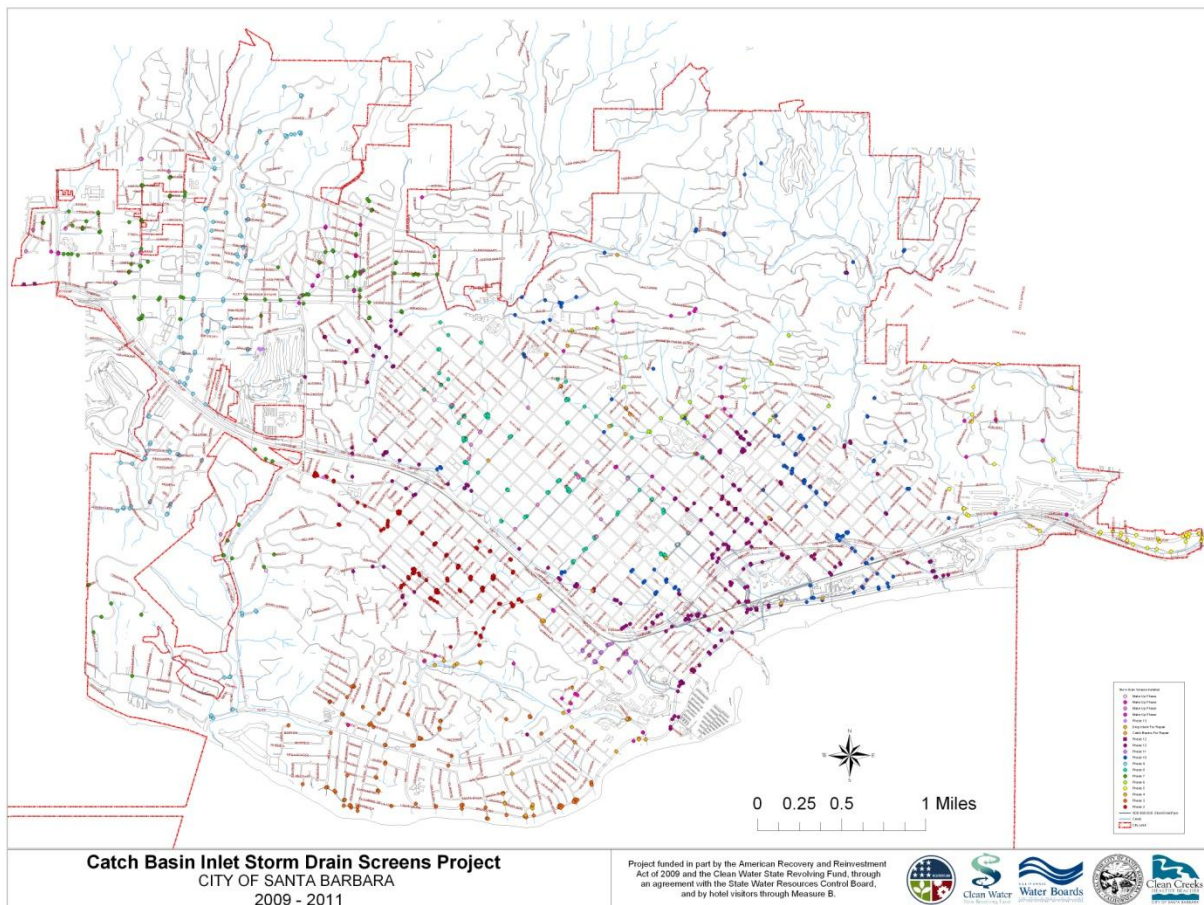
**Figure 1.** Project Map with Installed Catch Basin Screen Locations. Different colors represent different phases of installs during project construction.

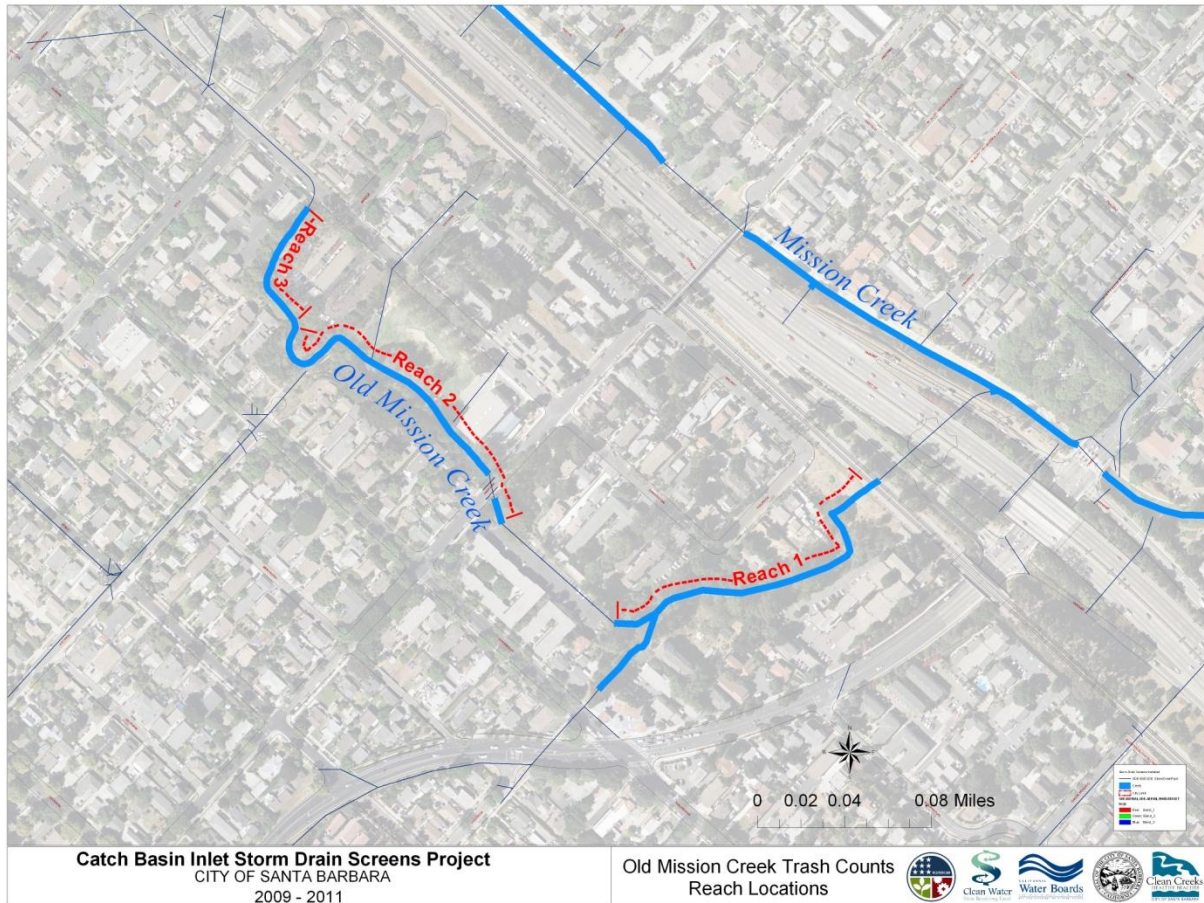
**Figure 2.** Creek Trash Count Map with Reach Locations.

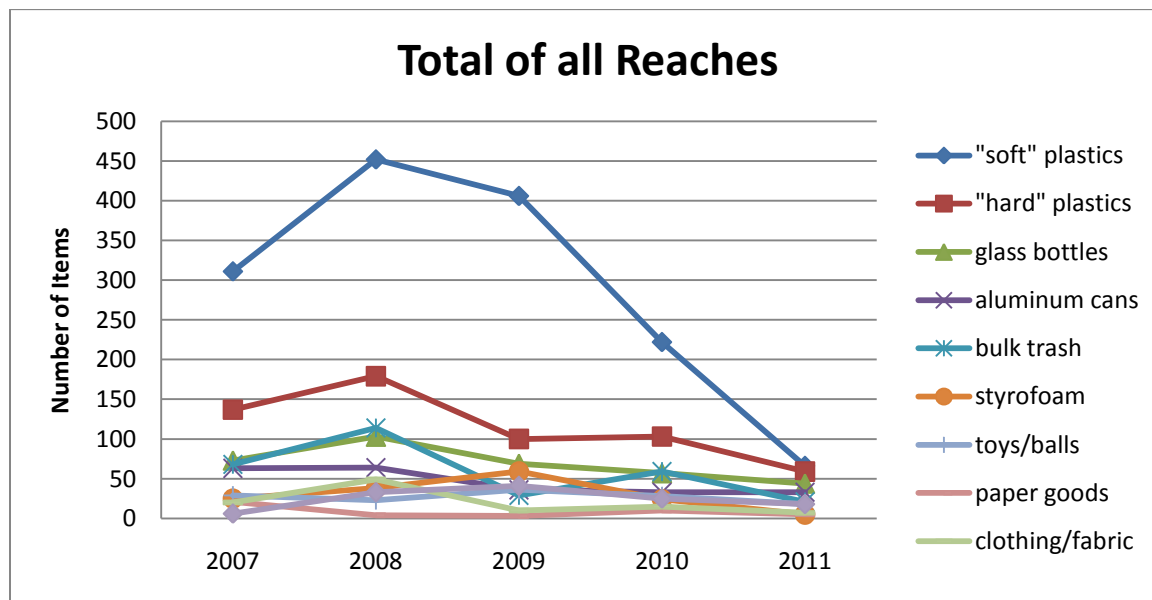
**Figure 3.** Trash Counts for all of Old Mission Creek 2007-2011. 2009 is the first count after screens were installed.

- "Soft" plastics, such as plastic bags made up the majority of the trash found in the creek.
- Trash in counted in the creek at the end of each summer was most likely carried from the storm drain inlets during the previous winters' rain events.
- The amount of trash items found in the creek in 2011 was 26% of the amount of trash items found at the peak in 2008, a 74% reduction.
- Each year following project installation shows further reduction of trash. This is likely due to the catch basin screens blocking trash from entering the storm drains and creeks, while the existing trash is cleaned or carried further downstream by each winter's storms.

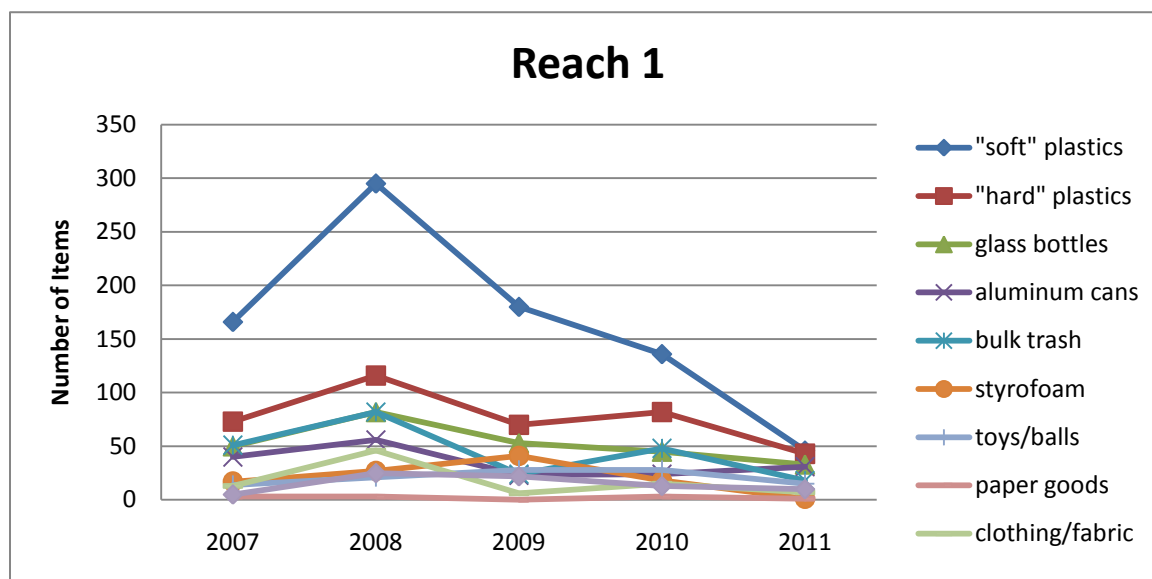
**Figure 4.** Trash Counts for Reach 1 of Old Mission Creek 2007-2011. 2009 is the first count that took place after screens were installed.

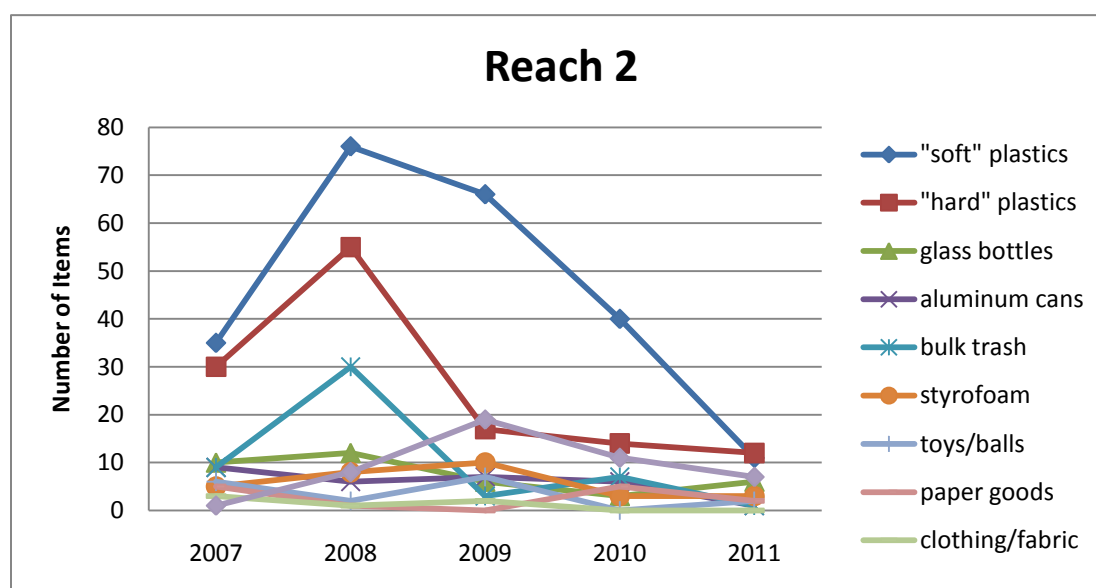
**Figure 5.** Trash Counts for Reach 2 of Old Mission Creek 2007-2011. 2009 is the first count that took place after screens were installed.

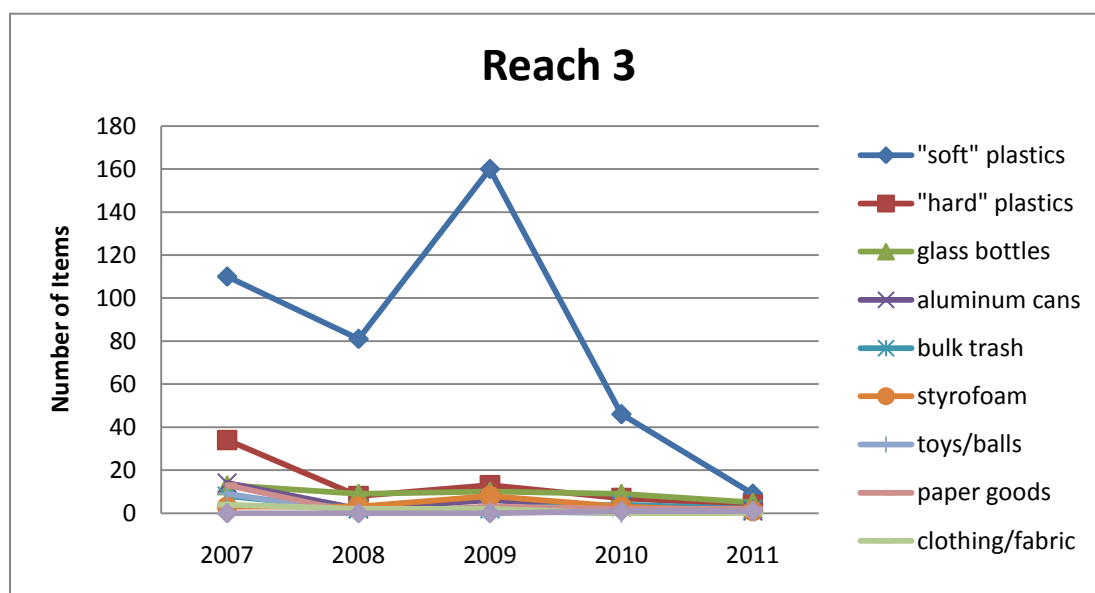
**Figure 6.** Trash Counts for Reach 3 of Old Mission Creek 2007-2011. 2009 is the first count that took place after screens were installed.

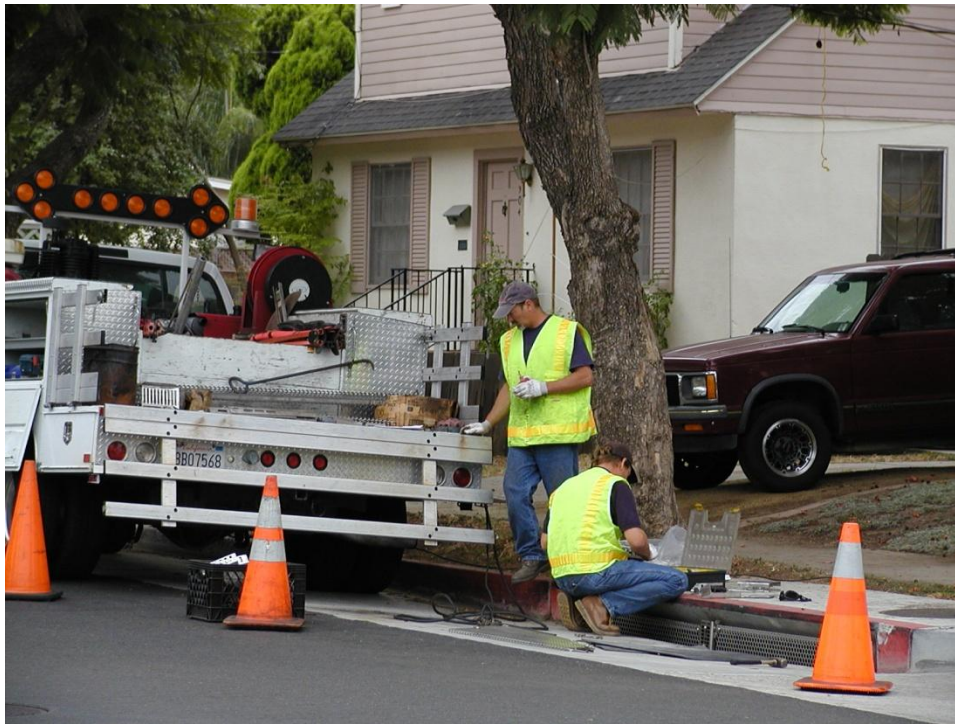
Installation of storm drain screens in a catch basin

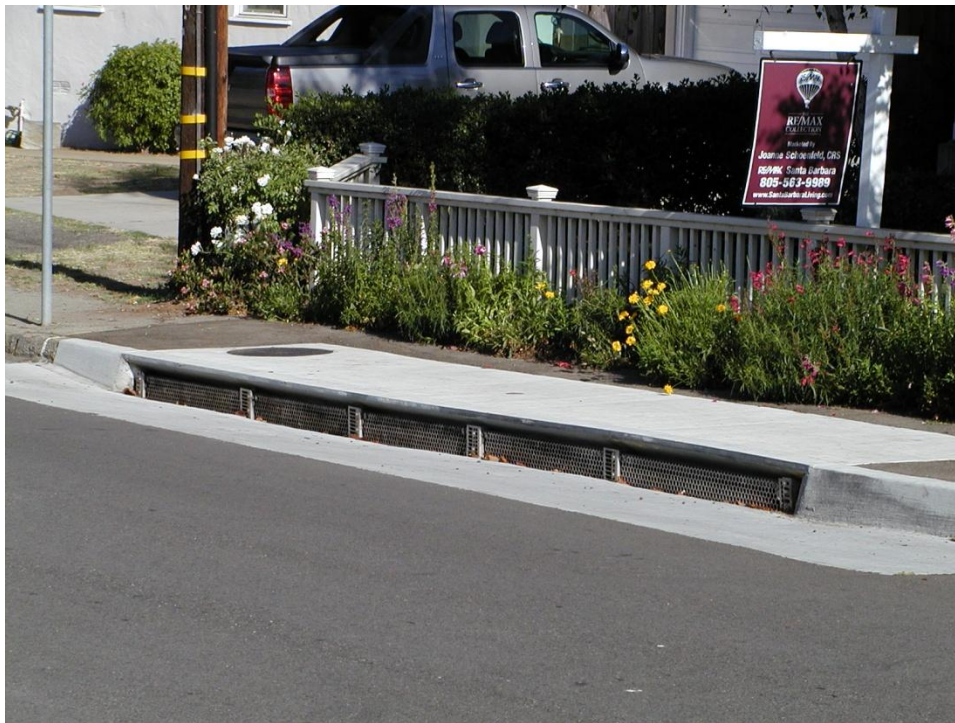
Installed storm drain screen

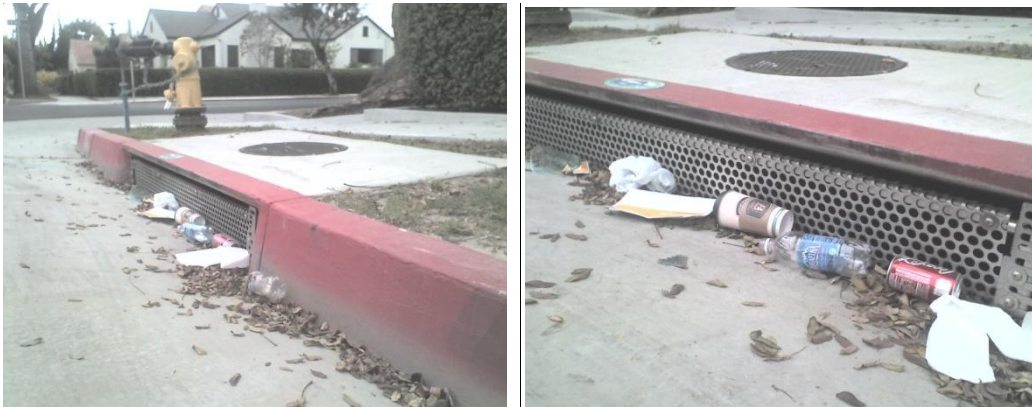
Trash and leaves in front of catch basin screen before street sweeping.

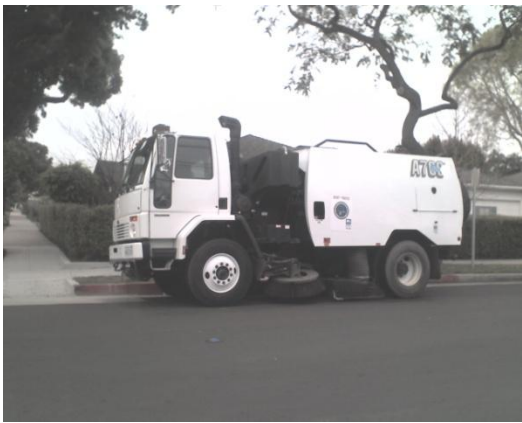
Street sweeping truck passing by catch basin (swept weekly).

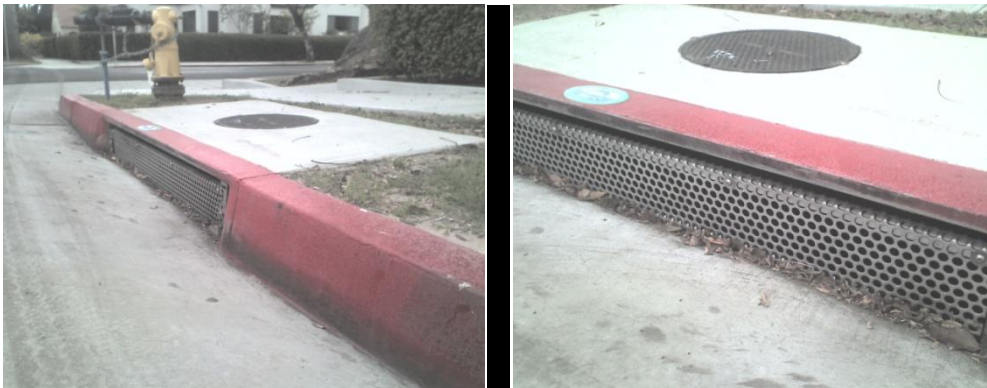
Catch basin immediately after street sweeper passed.

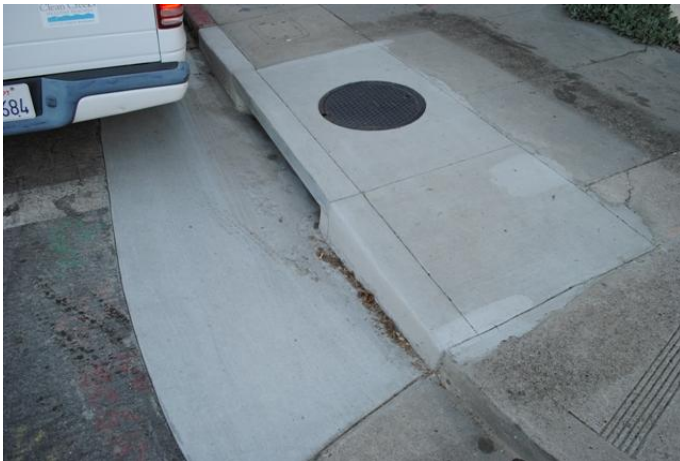
27 East Cota Street – Repaired Catch Basin

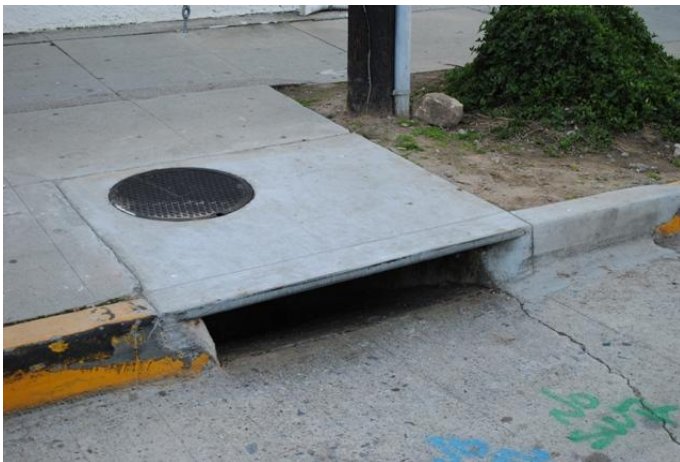
432 East Victoria Street – Repaired Catch Basin

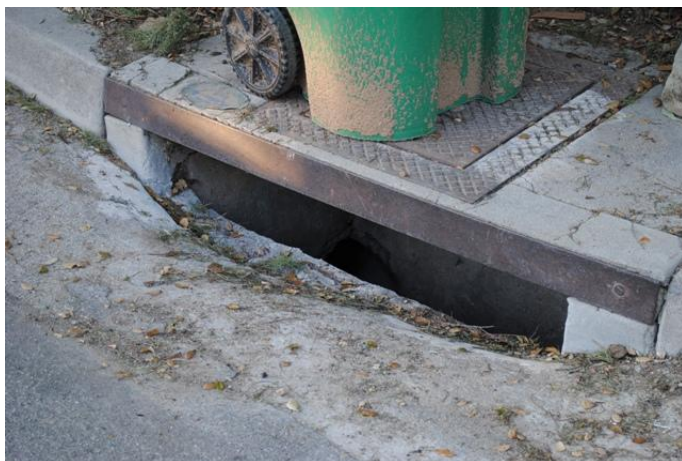
1836 Loma Street – Repaired Catch Basin

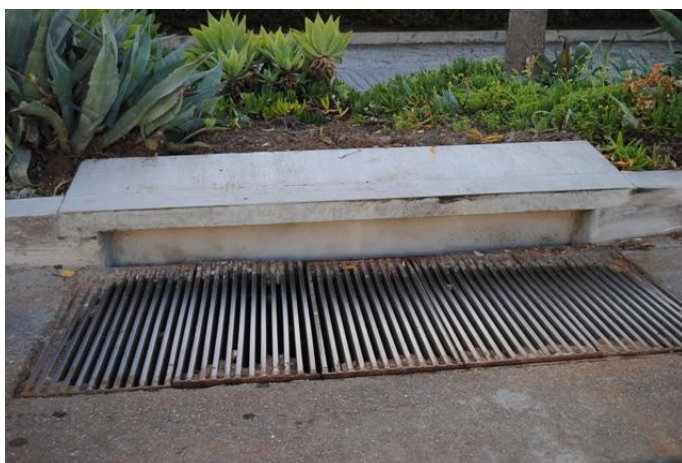
2000 Emerson Avenue – Repaired Catch Basin

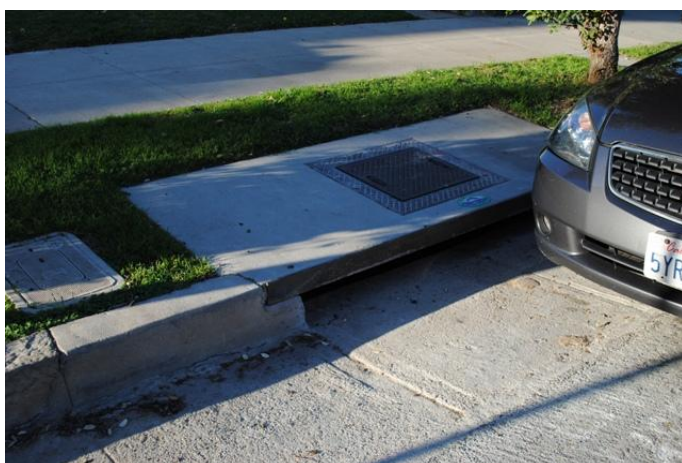
419 East Sola Street – Repaired Catch Basin

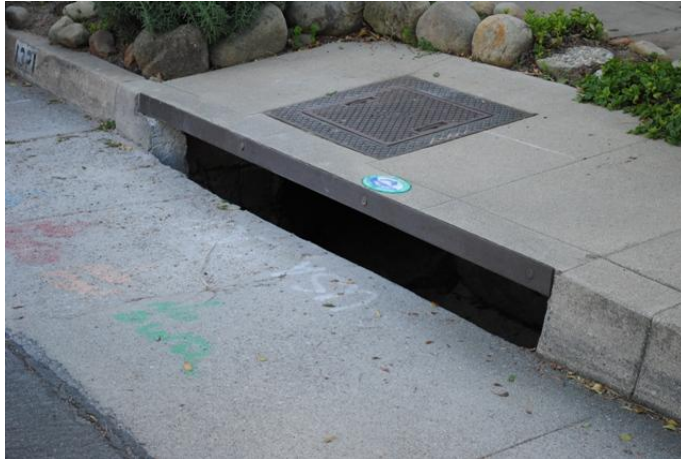
1321 Salsipuedes – Repaired Catch Basin

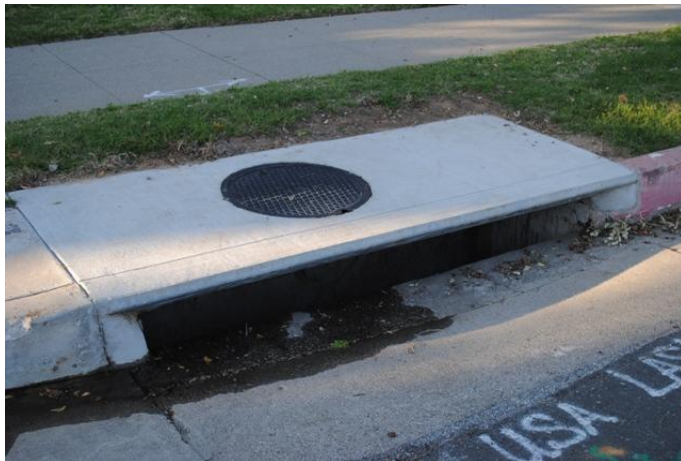
601 East Sola Street – Repaired Catch Basin

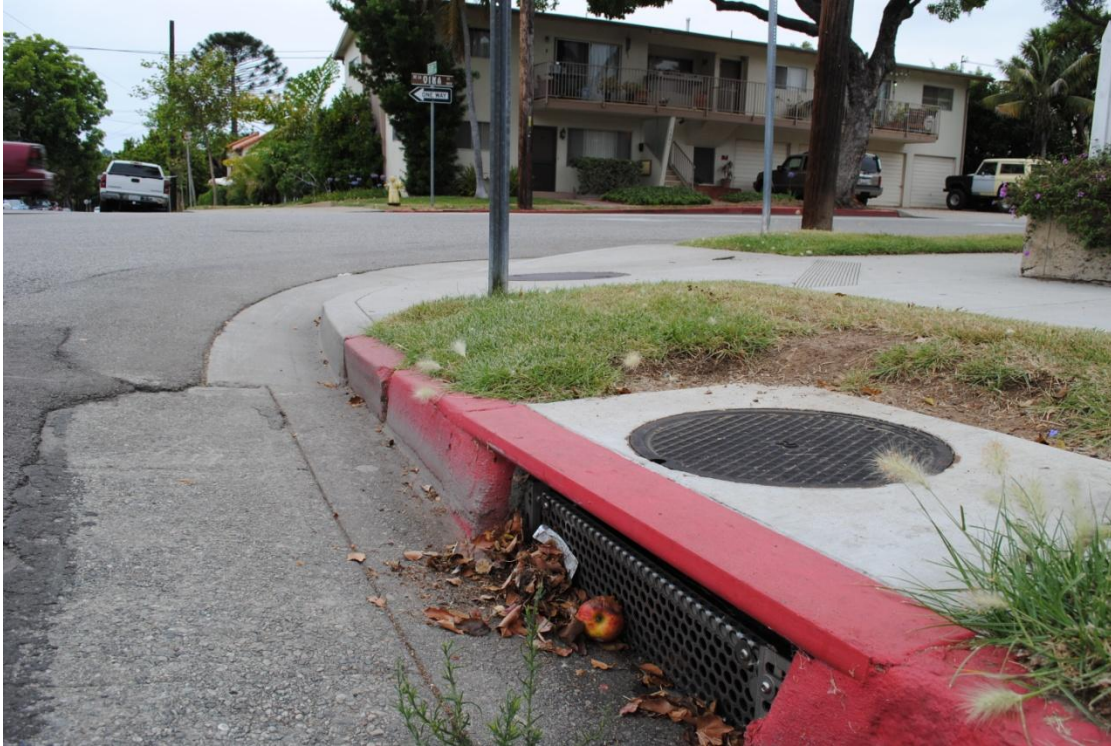
CB-E07-05 126 W Islay– Storm Drain Screen installed in repaired catch basin

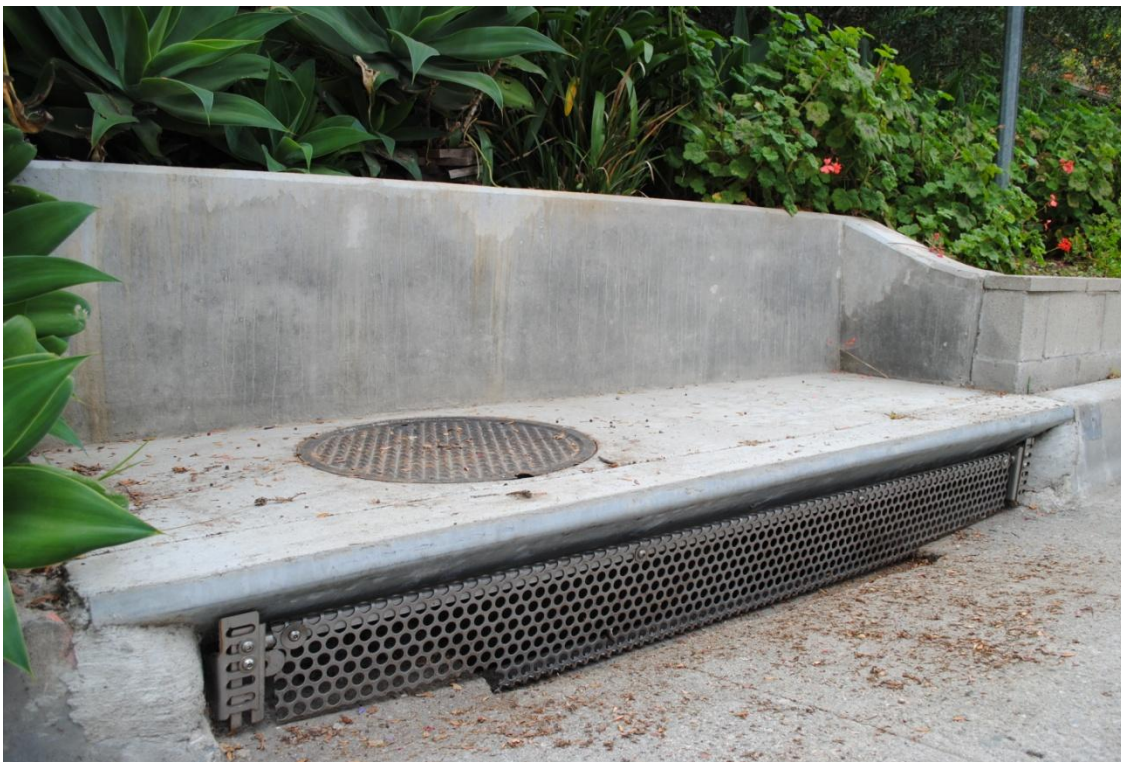
CB-F06-20 411 E Islay – Storm Drain Screen installed in repaired catch basin

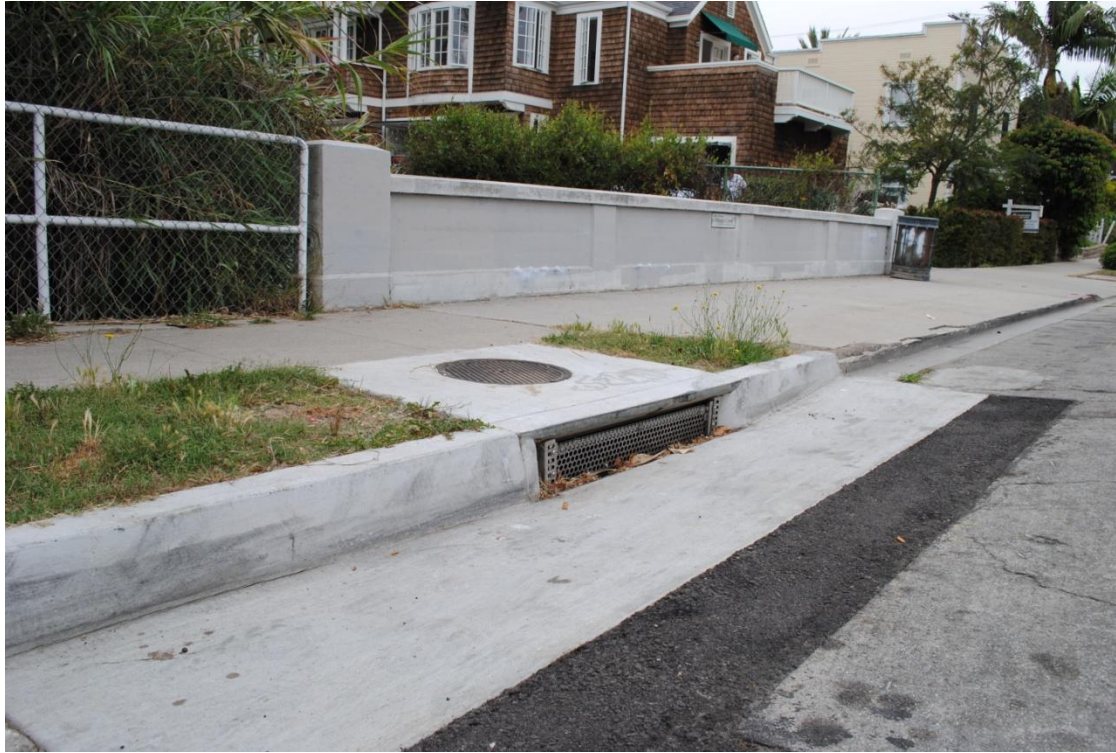
CB-F09-10 326 W De La Guerra— Storm Drain Screen installed in repaired catch basin

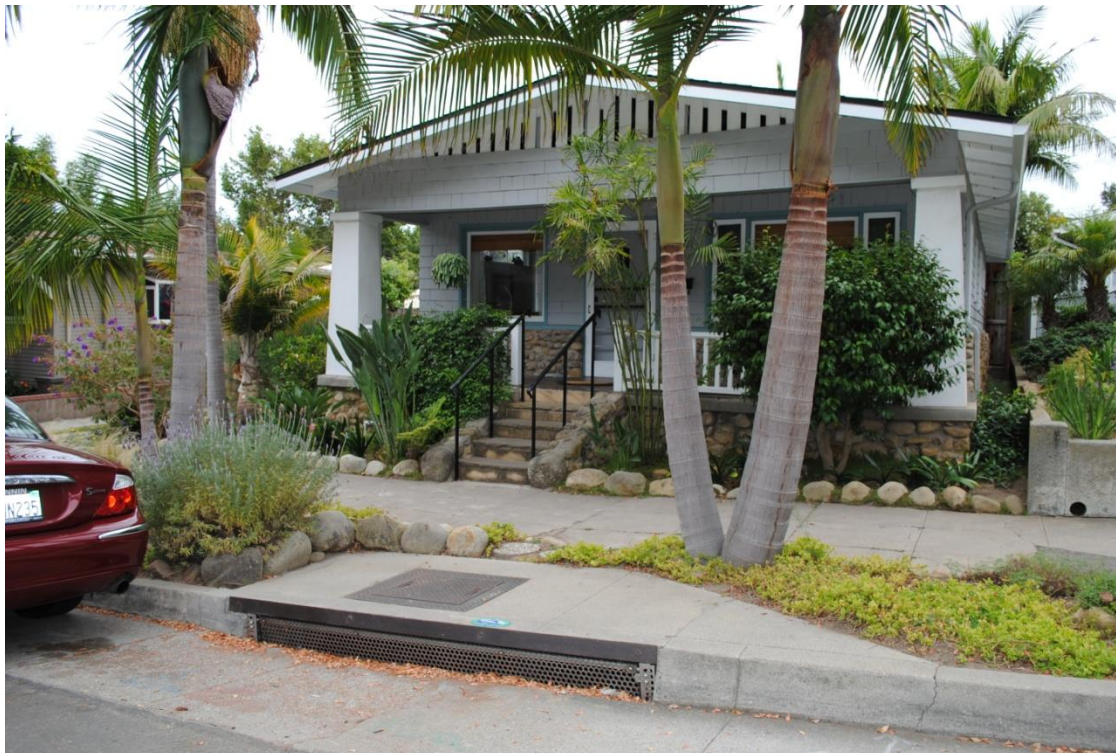
CB-G07-13 1321 Salsipuedes— Storm Drain Screen installed in repaired catch basin

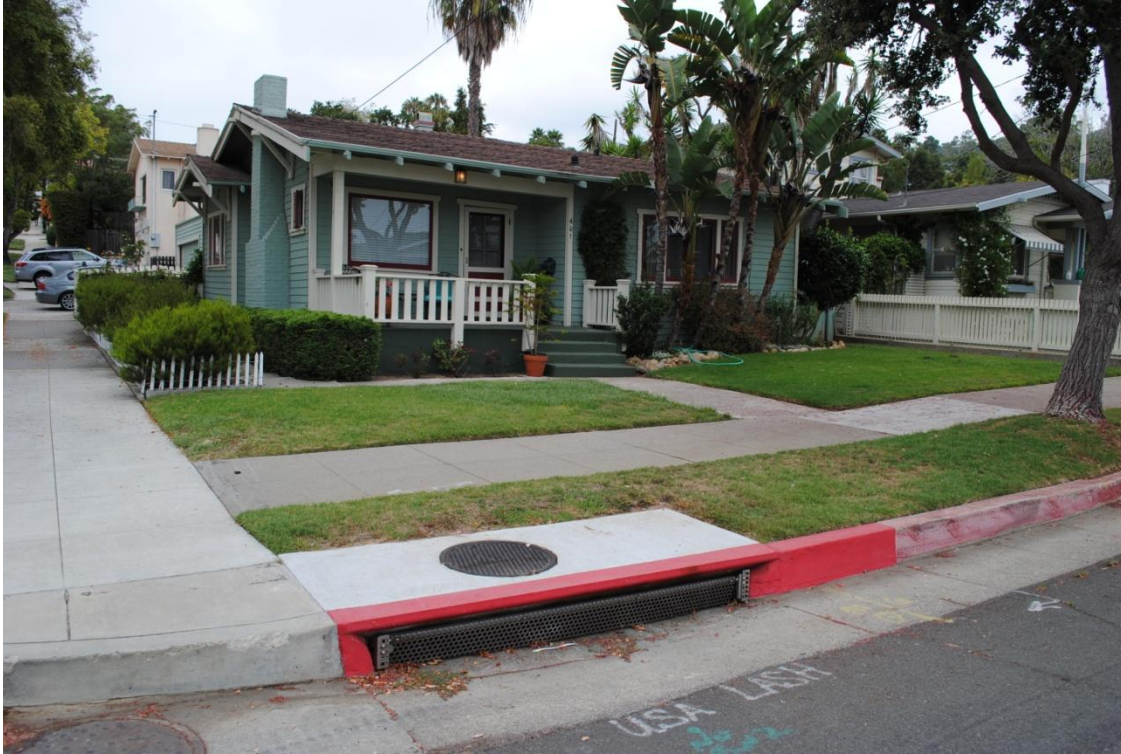
CB-G07-15 601 E Sola– Storm Drain Screen installed in repaired catch basin

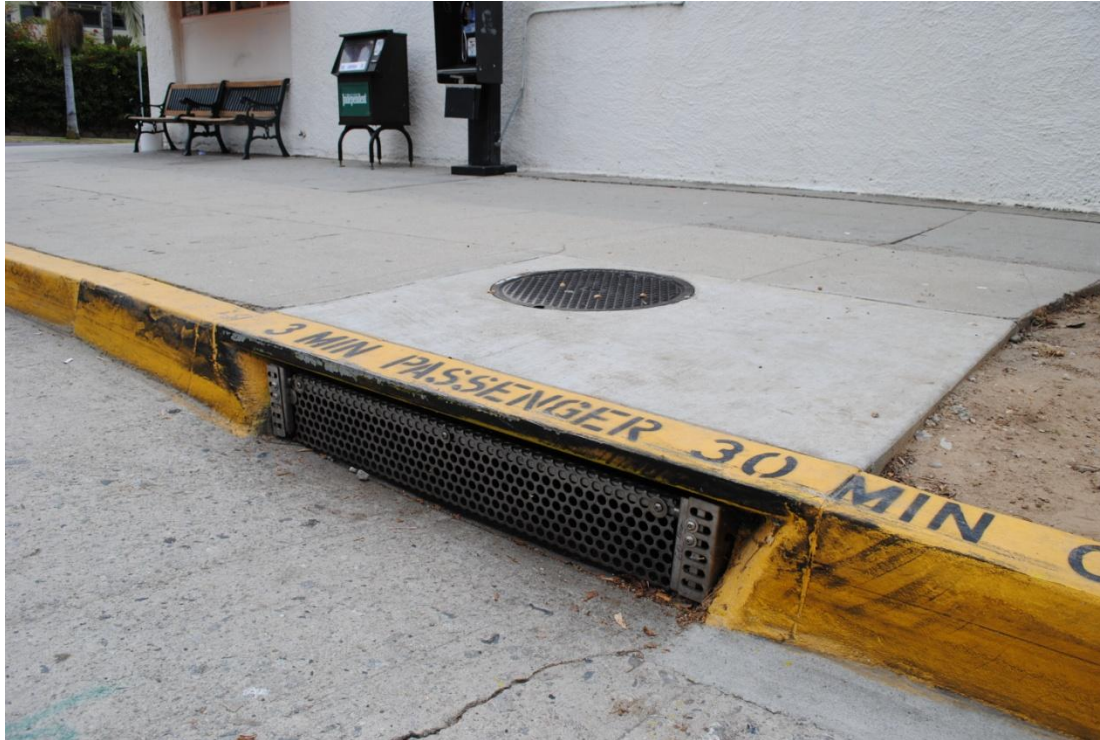
CB-G07-18 432 E Victoria– Storm Drain Screen installed in repaired catch basin
